Property Condition Assessment

169 Main Street, Lenox, MA

Inspection Date: Sept. 15, 2020

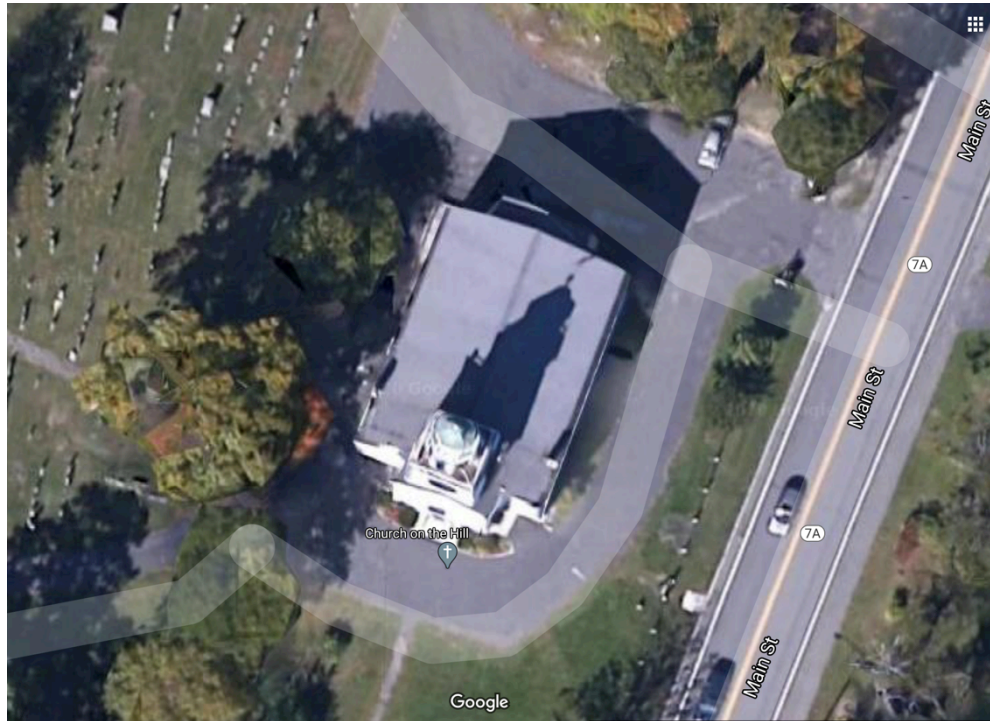
Site

Paving: There is no striping on the paving, which typically results in less efficient parking and a lower capacity. There are two parallel parking spaces along the western edge of the paving that are designated for handicapped parking via post-mounted signage only. These spaces are relatively close to the handicapped ramp. There is a small section of asphalt curbing along the north half of the western

border. In general, all the asphalt paving and curbs are in good condition. We recommend having a civil engineer develop an efficient parking layout so that spaces can be striped for more efficient parking when the building is in use. Also, because on-street parking is not available in this section of the town, the church might want to look into providing additional parking on the south side of the building.

Recommendations	Costs	Time Frame
Hire civil engineer to develop parking plan	\$4,500	Short-term
Stripe existing parking area	<\$3,000	Short-term
Repair or replace ramp handrail(s)	\$5,000	Short-term
Replace handrail at west-facing steps	<\$3,000	Short-term

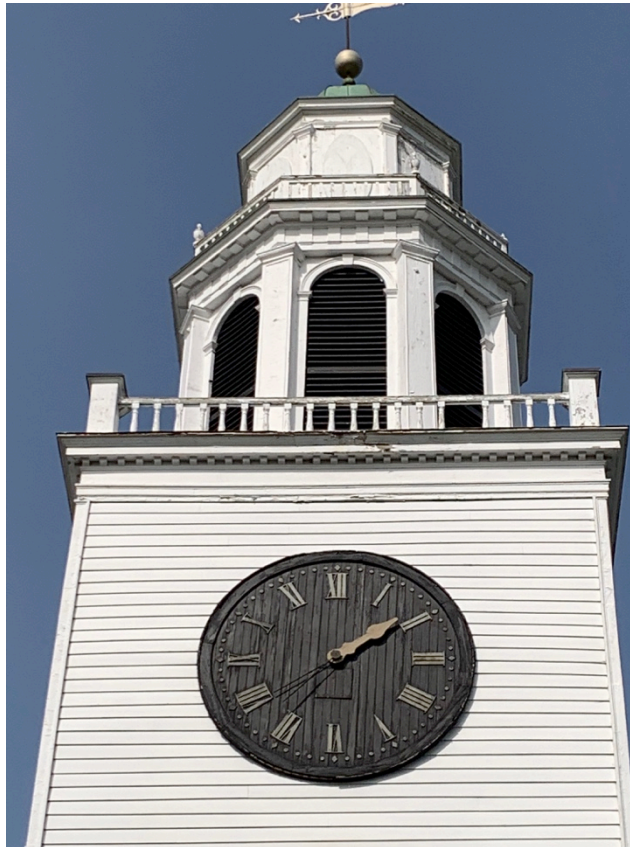
South Façade of Clock Tower

- Sidewall System: The entire building, including the bell tower, is covered with painted wood clapboard siding with corner pilasters and a cornice with dentils. The siding is relatively new and in very good condition. There are a few spots around fasteners on the west side that should be touched up. There is also a piece of the cornice on the northwest corner that needs to be replaced. Above the Clock Level of the bell tower is an octagonal belfry with Roman-arched vented openings and smaller balustrade and an octagonal cupola with a bell-shaped roof and weathervane atop it. There appears to be some damage to the cornice above the clock on the south side. In addition to repairing the cornice, all the wood boards and trim from the Clock Level cornice to the cornice below the copper roof should be scraped and repainted. Any other damaged or missing woodwork should also be replaced at that time. The trim on the Palladian window on the west side of the Clock Level should also be scraped and repainted.

- **Parapets & Balustrades:** There is one baluster missing from the south side of the balustrade capping the Clock Level and one urn missing at the southwest corner of the uppermost balustrade. These missing pieces should be replaced and both balustrades should be scraped and repainted. Any other damaged or missing woodwork should also be replaced at that time.

Repair/replace/repaint upper portions of bell tower	\$7,500	Short-term
Restore 11 First Floor windows to full operation	\$11,000	Short-term
Provide interior storms on 12 balcony windows	\$9,000	Short-term
Replace north & west entry doors	\$10,000	Short-term

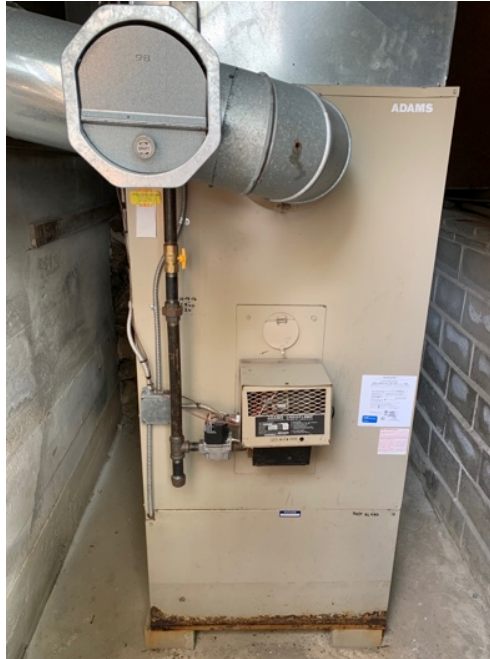
Furnace in Partial Basement

- Type: Gas. There is one Adams Manufacturing 350,000 Btu/hr. gas-fired forced air furnace with an efficiency rating of 80% (model no. AACOV 350) in the basement that serves the entire building. Combustion air is provided by a Fields Control Fan-in-a Can (model no. CAS-4) ducted to a sidewall vent on the west side of the building.

- Age: According to the serial number, this furnace was manufactured in December of 2014 and probably installed in early 2015. While it is impossible to predict with certainty when these units will fail, the average life for a furnace of this type is 15-20 years so there is plenty of useful life left in this unit.

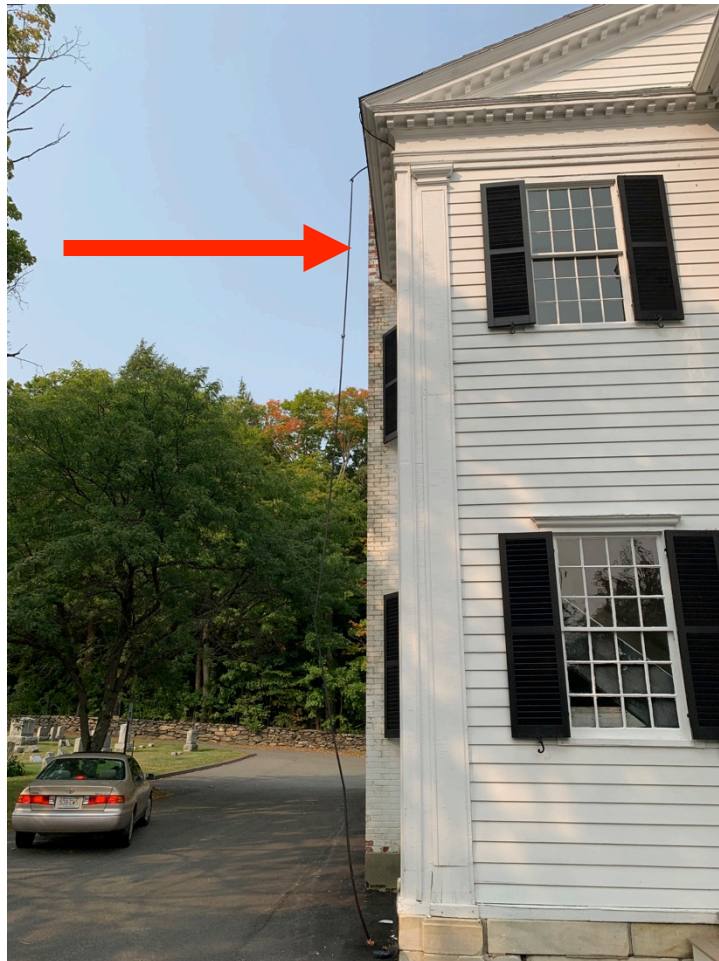
Original Ben Franklin Design Lightning Protection System

- **Emergency Power:** No emergency power was observed at the time of inspection.
- **Lightning Protection:** This system was upgraded in 2010 and last repaired and inspected in 2015. The system incorporates portions of the original Benjamin Franklin design. This system is due for reinspection.

Recommendations	Costs	Time Frame
Have lightning protection system inspected	<\$3,000	Immediate
Upgrade exterior lighting for front façade	\$5,000	Short-term
Repair & automate the clockworks	\$15-20,000 ¹	Short-term
Upgrade interior lighting for use after sunset	\$40,000	Unpredictable

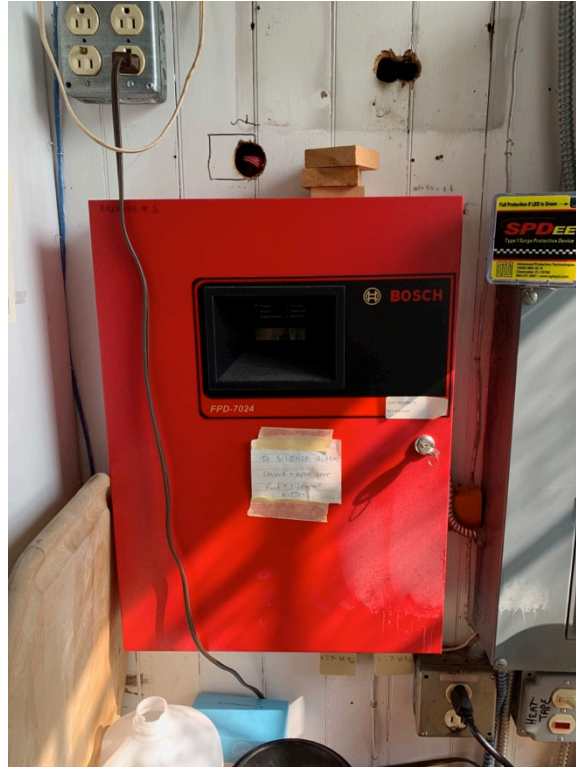
Fire Alarm Panel

Fire Alarm System: The existing system consists of a main panel in the Sacristy (Bosch model no. FDP-7024). The building is equipped with a single pull box and strobe located between two of the exit doors from the Narthex,

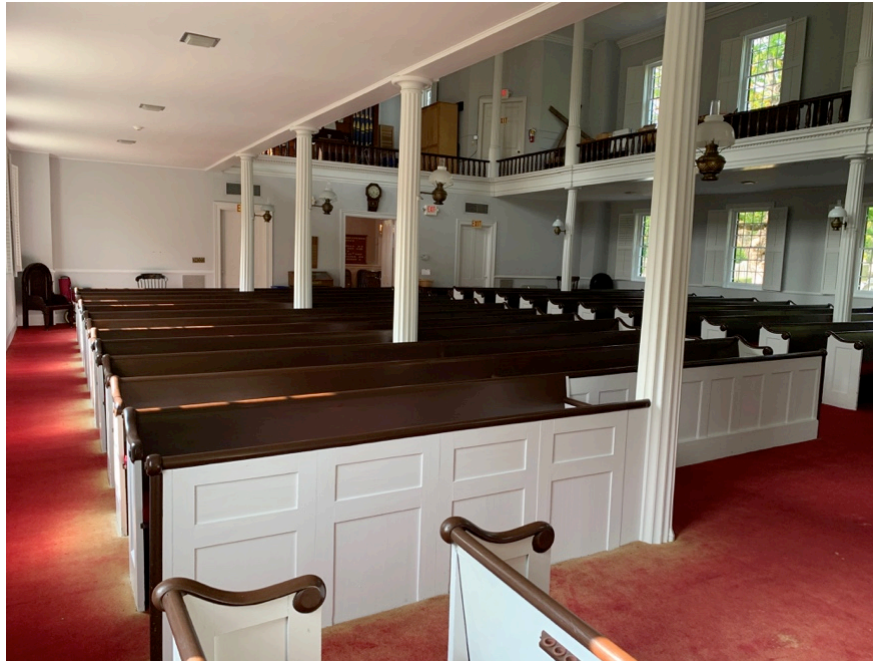
Typical First Floor Finishes

pew ends and frontals. All the carpet should be replaced or the flooring beneath it exposed and refinished. The Sacristy and Toilet Room both have vinyl composition tile flooring, which is cracked in the Sacristy and should be replaced.

- Ceiling Finishes: Plaster in the assembly space and wood beadboard elsewhere. The ceilings under the balcony are generally in very good condition, with minimal cracking. The high ceiling over the central area is discussed under the Balcony Level.
- Wall Finishes: Plaster with wood panel wainscoting throughout, except the portion of the south wall between the doors. There is cracking on most areas of the exterior walls; however, very little of it has resulted in loss of plaster or is abnormal for a building of this age.

Recommendations	Costs	Time Frame
Inspect plaster keys of highest ceilings	<\$3,000	Immediate
Replace carpeting throughout the First Floor	\$15,000	Short-term
Replace VCT flooring in Sacristy	<\$3,000	Short-term

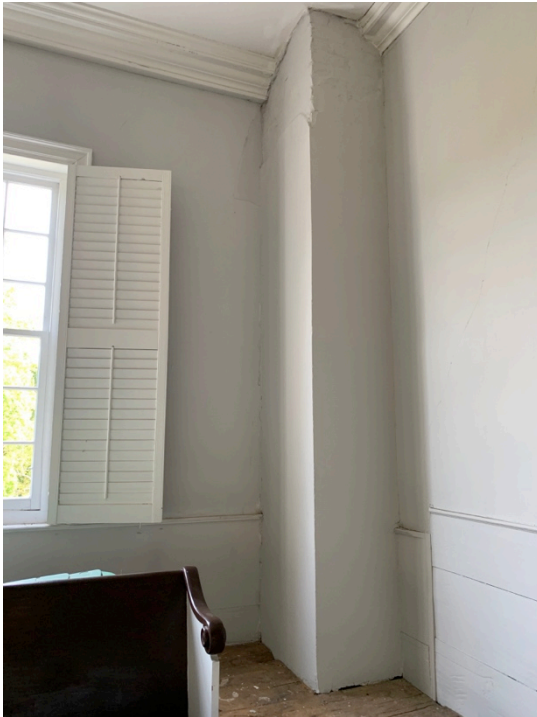
General Balcony Level Finishes

- Wall Finishes: Plaster on wood lath with horizontal wood board wainscoting. There is cracking on most areas of the exterior walls; however, very little of it has resulted in loss of plaster or is abnormal for a building of this age. The most significant area of plaster cracking is in the east stairwell which appears to be used as a service stair/storage room and therefore has not been as well maintained as the rest of the building.

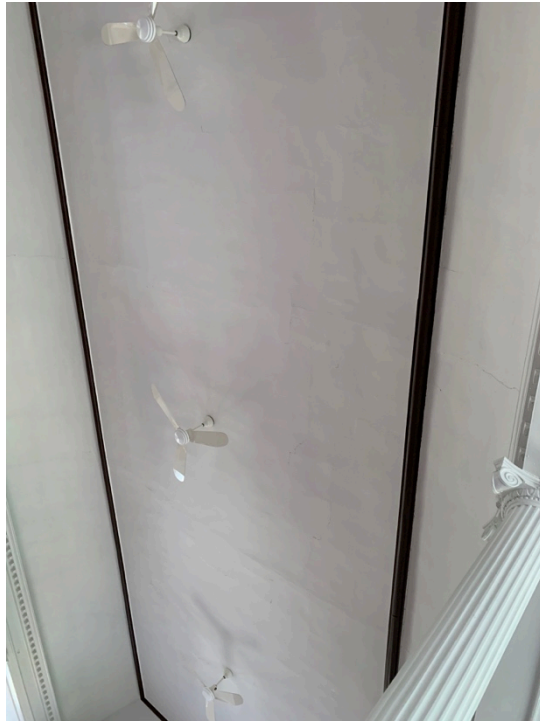
Tray ceiling

- Floor Coverings: There are no floor finishes on this level – just exposed wide boards or plywood, some of which has been painted.
- Ceiling Finishes: Both the flat ceilings over the balcony and the tray ceiling over the center of the assembly space are plaster on wood lath. The condition of the flat ceiling is much better than the condition of the tray ceiling. While both have cracks, the flat ceilings continue to maintain their flatness while the tray ceiling has many visible surface irregularities. While this inspection did not include inspection of the plaster keys in the wood lath, it might make sense to

examine at least the tray ceiling to determine if the plaster is starting to lose its integrity and is in danger of failure. The cracking in this ceiling is significant.
