Property Condition Assessment

169 Main Street, Lenox, MA

Inspection Date: Sept. 15, 2020

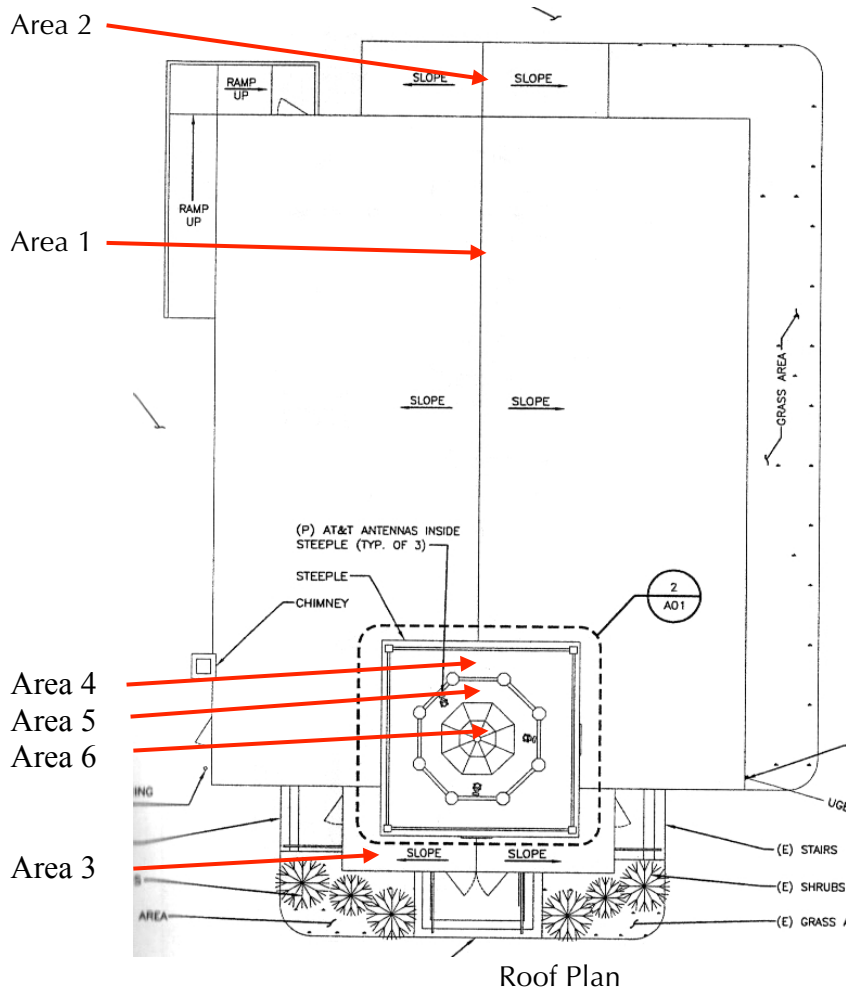
Area 1: This describes the sloped roof that covers the majority of the building. It consists of a steeply pitched gable roof running north-south. This roof is covered with asphalt shingles, with metal snow slides along the eaves. It appears to be in good condition. There are no stains in the ceilings indicating active leaks.

Area 2: This is the area over the projection on the north side of the building, where the raised platform is located. This asphalt shingle roof also appears to be in good condition. There are no stains in the ceilings indicating active leaks.
